The Collapse of the Header

beneath Trojska street, Prague

The Collapse of the Trojský Header

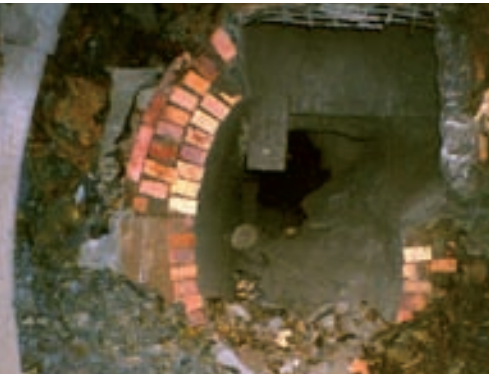
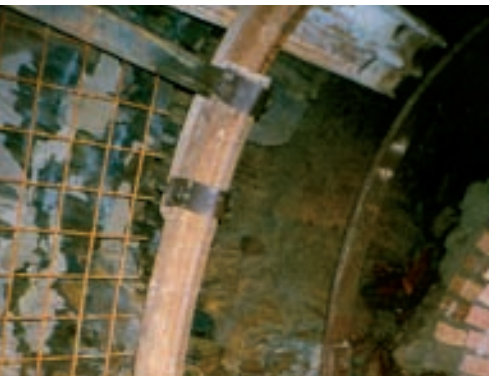
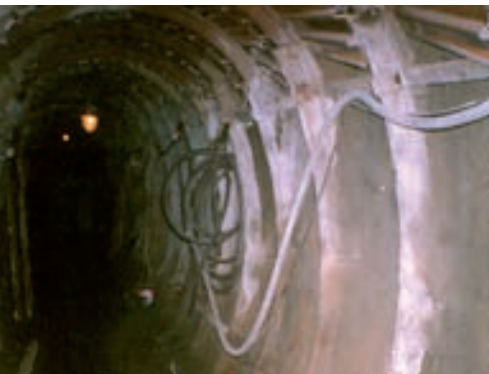
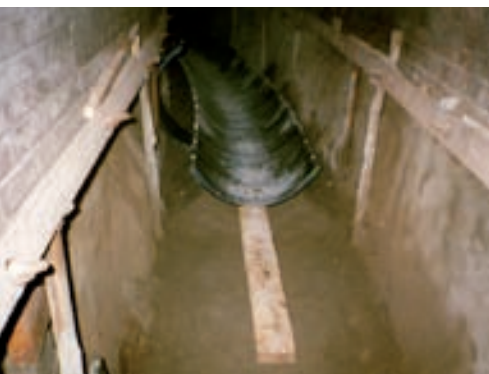
Detailed exploration of the header, using the most up-to-date geotechnical reconnaissance methods, continued to obtain the most detailed information not only in regard to the actual extent of damage to the header, but also to the status of the rock mass behind the extrados.

The result of the survey clearly confirmed the correctness of this procedure, since it identified the existence of additional caverns behind the extrados that till then had not manifested either in the flow-profile of the header nor on the surface, but which, if left unnoticed, would be a potential source of additional failure of the header, together with all its accompanying surface phenomena.

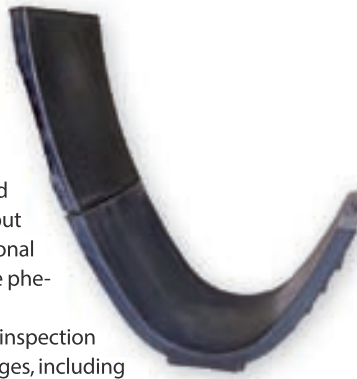
To determine the extent of the actual damage to the sewer an inspection of the entire sewer in Trojská Street was carried out in several stages, including photographic documentation and the surveying of the caverns. This survey, which was carried out in unstable caverns and under very difficult conditions, nevertheless provided sufficient basic information concerning the status, the geological condition, the degree of stability and the other parameters requisite for the project engineer to design a method for implementing the stabilisation of the rock mass and its timing. The results of these surveys were discussed with Prof. Ing. J. Barták, DrSc. from the Faculty of Civil Engineering of the CTU, who had also directly participated in the inspection and in the assessment of the stability of the individual caverns.
