Sewer Reconstruction

on Pařížská Street in Prague

Technical Parameters of the Construction

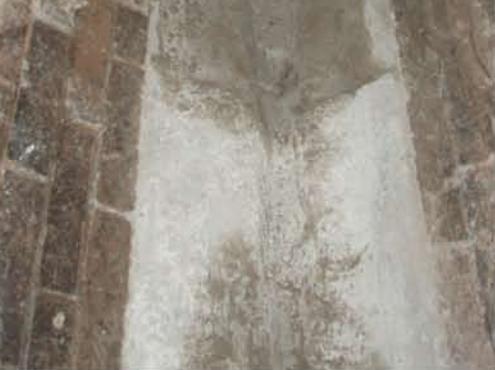
1

The abraded earthenware block located at the bottom of the sewer

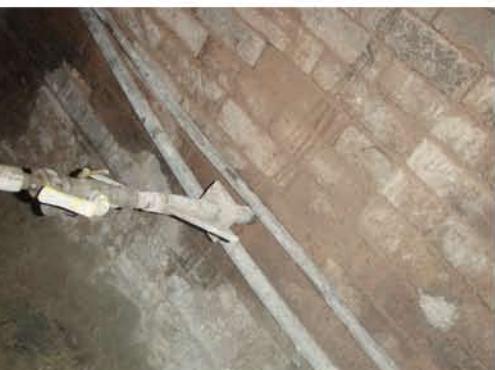
2

Filling-in the voids behind the lining with the grouting mixture

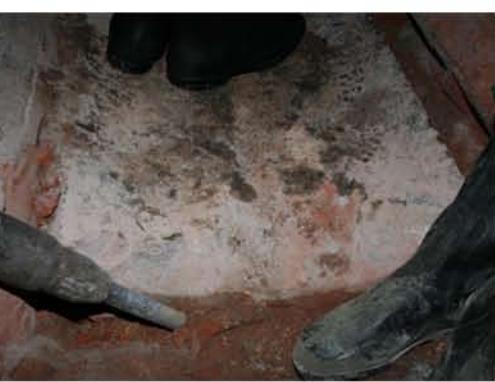
3

Removing half of the ceramic groove

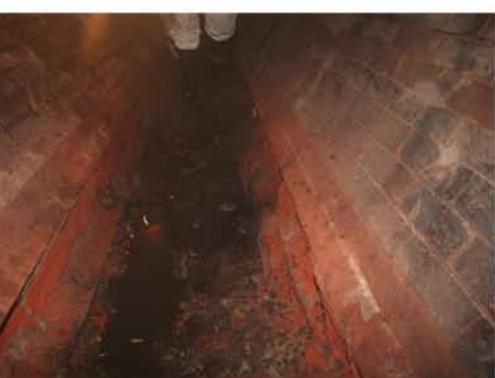
4

Pulling out two rows of bricks

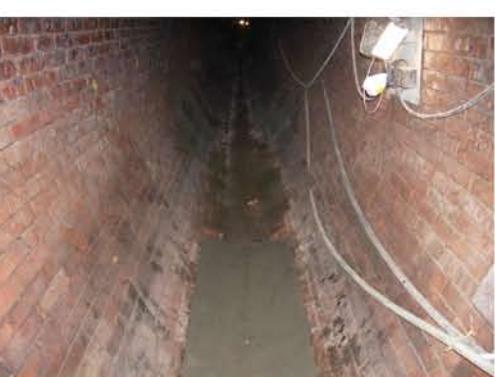
5

Rough filling of the space above the area from which the damaged gutters were removed with concrete

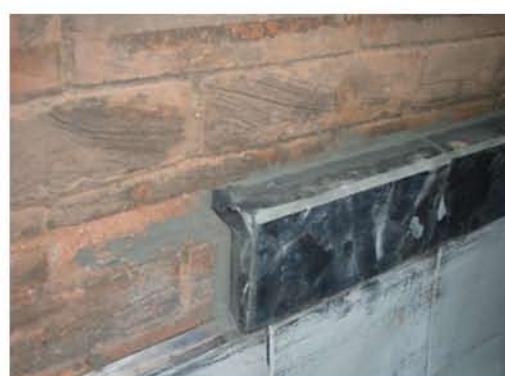
9
Pasting the interlocking cast basalt block into the prepared groove

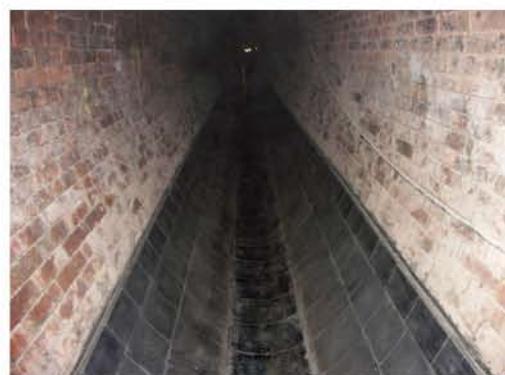
fáze 10
The bottom part, lined with cast basalt, terminated with an interlocking block
