The Collapse of the Header

beneath Trojska street, Prague

The Collapse of the Trojský Header

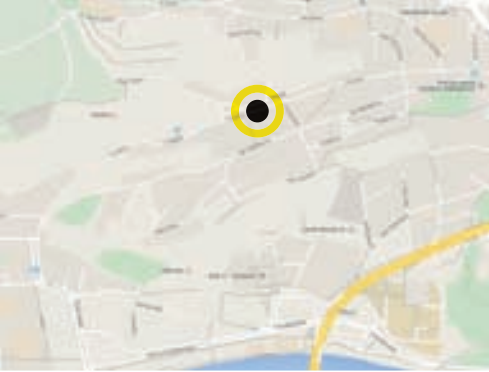
The process of the collapse of an entire section of the header evolved over a very short period at the beginning of July 1996. In late June, sewerage bricks were found in the Trojská rainwater separator during its regular inspection. However, the subsequent high level of rainfall prevented any inspection of the header and this was probably one of the causes of its collapse, which was unprecedented in the Prague sewerage network. The first evident manifestation of the accident was both very dramatic and rapid. On the 4th of July 1996, close to a tram stop, cca. 20 metres from the tram track, a funnel sinkhole appeared, with a diameter of cca. 16 m at ground level and a depth of 12 m, at the bottom of which wastewater was flowing. The sewer construction was completely destroyed and washed away. Directly connected to this sinkhole (hereafter referred to as P1) was a downstream cavern with a length of about 10 m and a height of cca. 3 m.
